Evaluation of Road Pavement Monitoring System

Christoph Mertz (cmertz@andrew.cmu.edu), October 2017

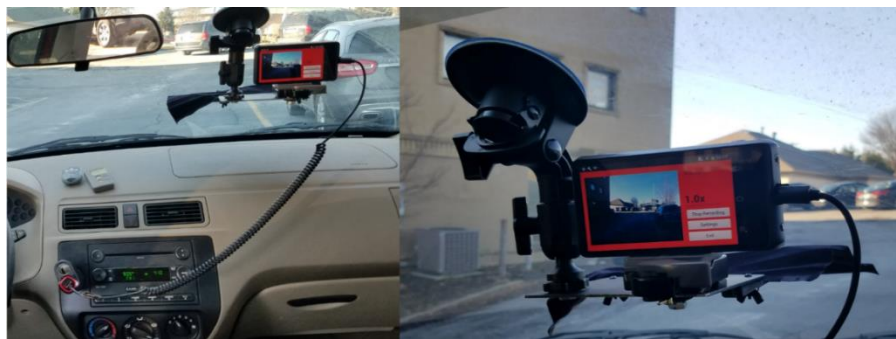
The data used are GPS tagged images collected with a smartphone that can be mounted in any vehicle (Figure 1).

Figure 1: Smartphone mounted in the windshield of a car and powered by a 12V outlet.

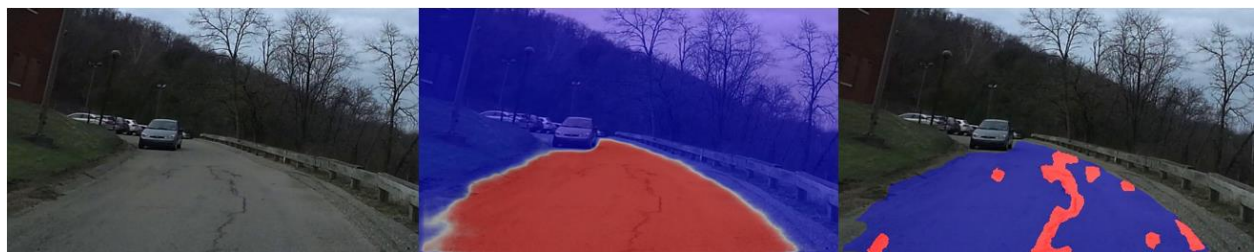
After the collection, the data is downloaded to a server via WiFi. The images are analyzed to determine the amount of cracks in the pavement. An example is shown in Figure 2.

Figure 2: Left: Raw image. Middle: Detection of road area. Right: Detection of cracks.

The first algorithm determines the area of the image that contains the road. The second algorithm detects the cracks inside the road area. The ratio of the area that contains cracks to the area without

cracks gives a score for each individual image. This score is averaged over a street segment and converted to five levels, these levels are shown for Pittsburgh in Figure 3.

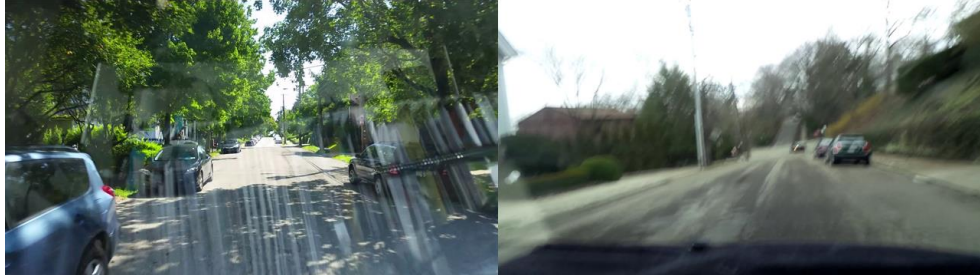
- **Time:** The road was paved between when we received the Cartegraph data and when we collected the road data.
- **Weather:** The data was collected during a snow day.
- **Distortions:** Glare, motion blur, etc. (see Figure 4)
- **Different measures:** The OCI considers additional distresses like rutting.

Figure 4: Examples of glare (left) and motion blur (right).

The scores of the road pavement monitoring system can be improved by discarding data that was collected during bad weather, reducing the glare with a reflection shield on the camera mount, detecting blur in images and discarding those with excessive blur, and finally training the algorithm for a greater variety of conditions.
