## Options for Improving the Safety of DUKW Type Amphibious Vessels (2021)

TRANSPORTATION RESEARCH BOARD  
SPECIAL REPORT 342

# Options for Improving the Safety of DUKW Type Amphibious Vessels

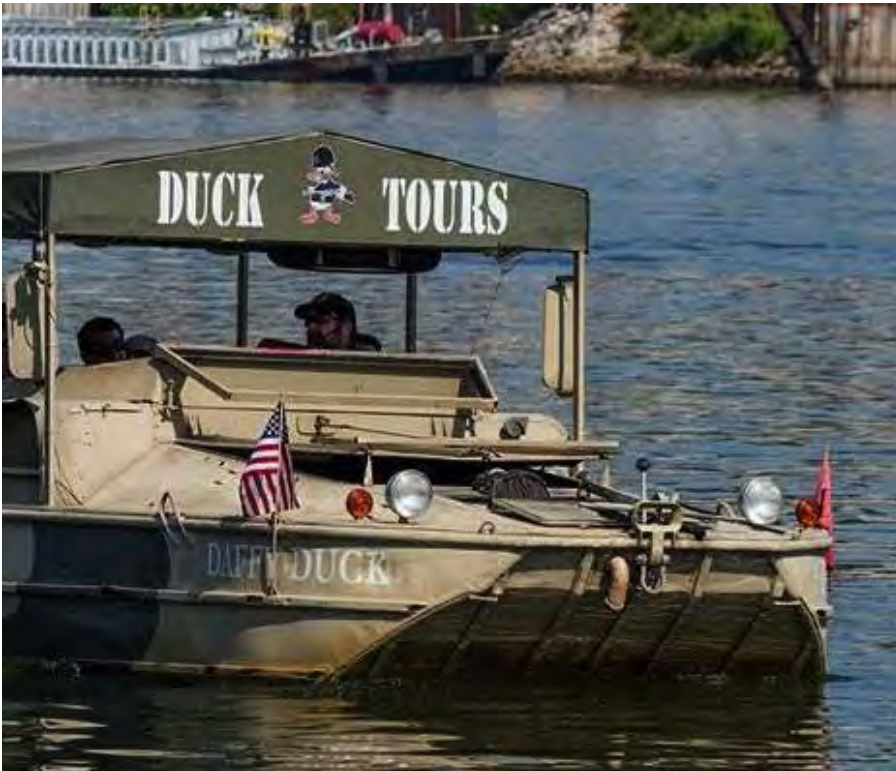
**FIGURE 3-4 WWII DUKW with an open hood hatch.**

DUKWs modified for commercial passenger use have either a large intake vent on the "hood" or a member of the crew props the forward hatch open to provide adequate cooling, particularly in high ambient temperatures (see Figure 3-4). This modification has contributed to DUKWs experiencing flooding, including the sinking of the *Stretch Duck 7* in 2018. Caught in a

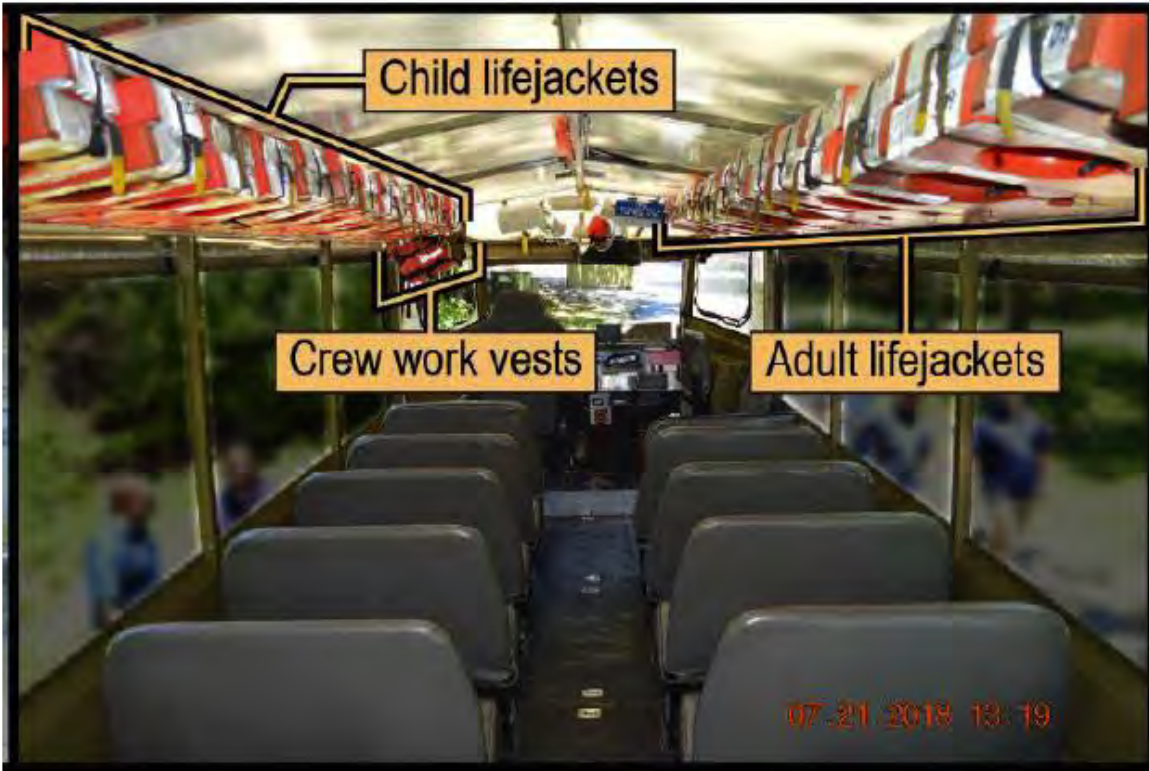
**FIGURE 5-1** Stowage of life jackets under the canopy from *Stretch Duck 7*.

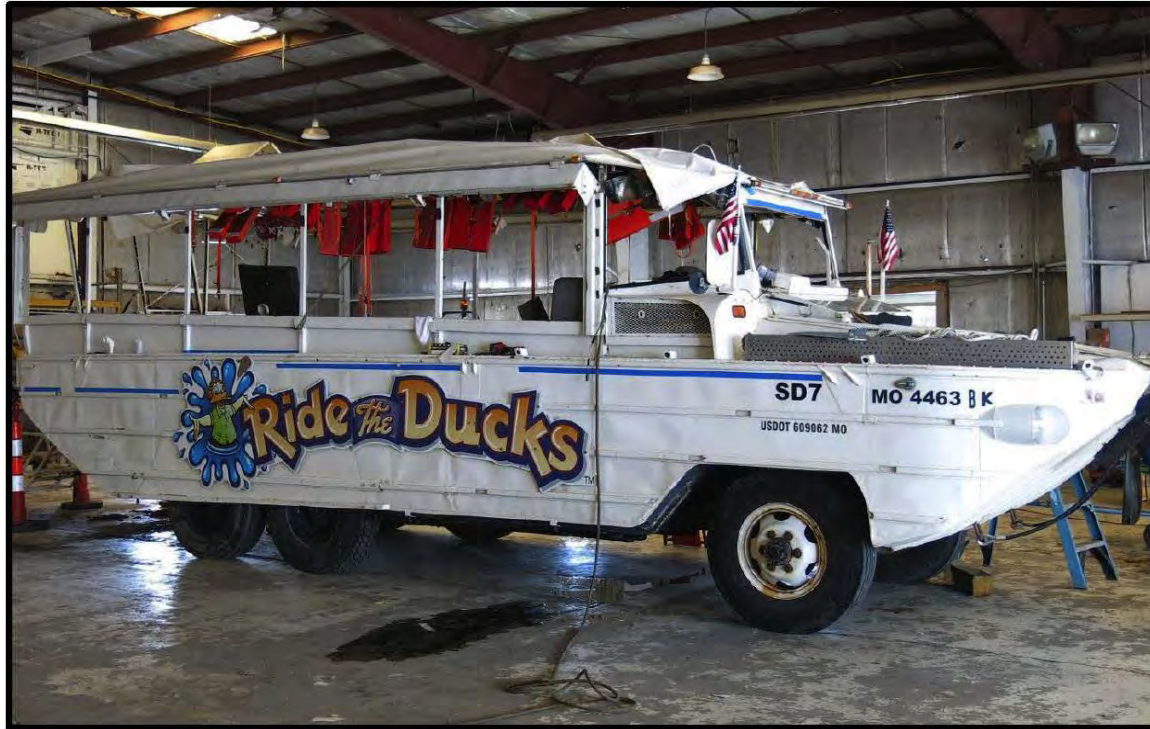
**FIGURE 5-2 Canopy on *Stretch Duck 7* after casualty.**

The canopy on the *Stretch Duck 7*, shown in Figure 5-2, included two side curtains, each made out of a single sheet of clear plastic that could be rolled down and up as needed. Figure 5-3 shows the plastic side curtains in the down or deployed condition. In emergencies, each curtain is released by its corresponding lever located on each side of the vessel. The release mechanism does not roll up the curtain; instead, the release mechanism causes the curtain to disengage at the top and fall away. On the *Stretch Duck 7*, one release lever was located on the port side above

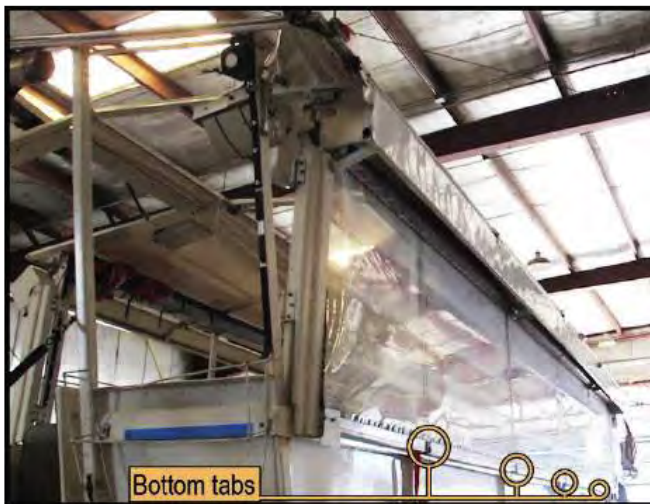
**FIGURE 5-3 Side curtain rolled down to protect passengers.**

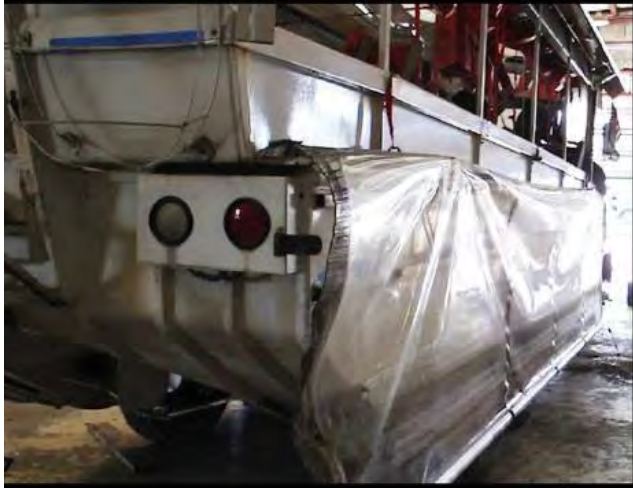
**FIGURE 5-4 Side curtain released for emergency exit.**

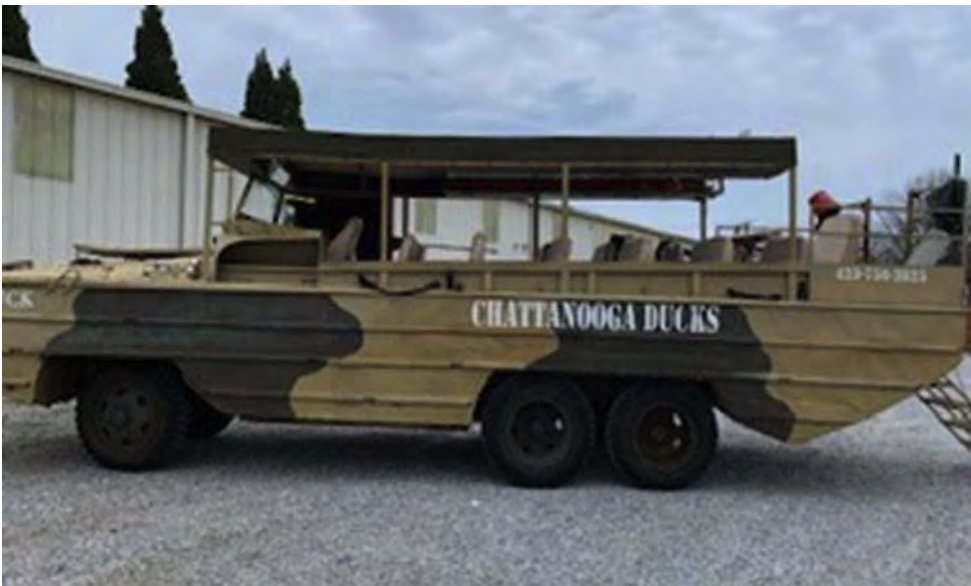
**FIGURE 5-5 Chattanooga WWII DUKW with shortened canopy.**

Some DUKW operators use shortened canopies, typically with no side curtains. Figure 5-5, a WWII DUKW operated by Chattanooga Ducks, has a shortened canopy so that the aft, raised

seating area is not covered. The canopy only uses four vertical supports on each side, spaced well apart. A person could also escape through the front, going around or over the windshield. Figure 5-6 shows an Original Wisconsin Ducks DUKW with another version of a shortened canopy, with no side curtains and open at the front and back. This configuration still has relatively closely spaced vertical supports that can impede escape over the side.

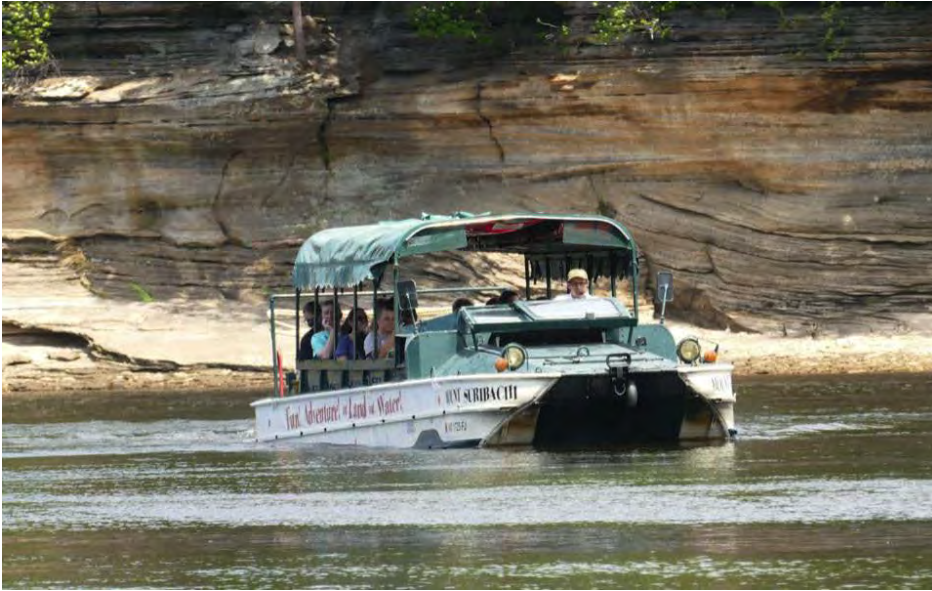
**FIGURE 5-6 Original Wisconsin Ducks DUKW with open, reduced-size canopy.**  
SOURCE: T. Graul, committee member.

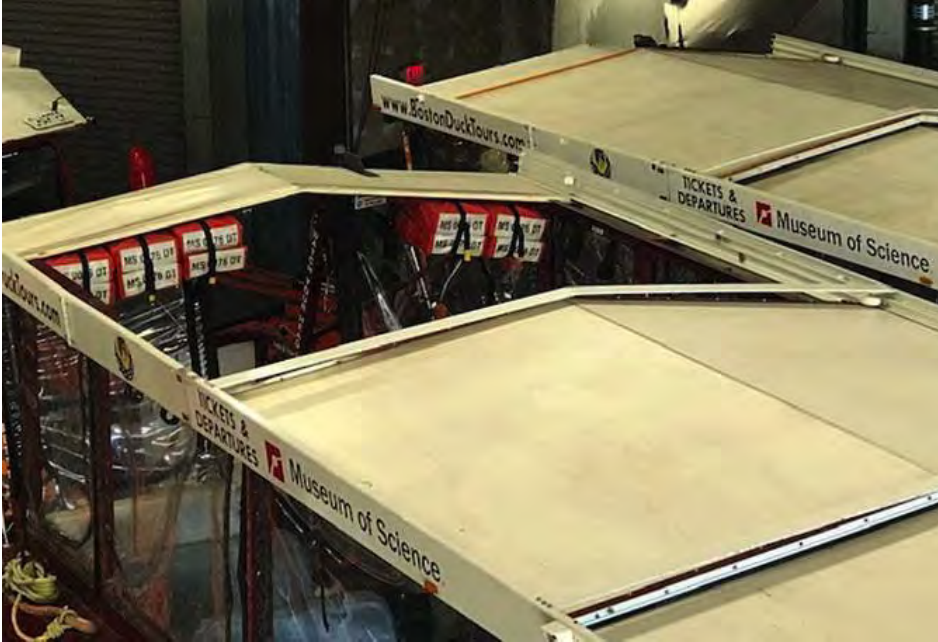
**FIGURE 5-7 Stern area slide roof on Boston Duck Tours.**

Boston Ducks, which has a fleet of Truck Ducks, uses a sliding hatch in its canopies. The canopies are constructed of a lightweight reinforced vinyl that is easy to cut. The hatch panel is 7 feet square, located in the stern area, and slides forward (see Figure 5-7).

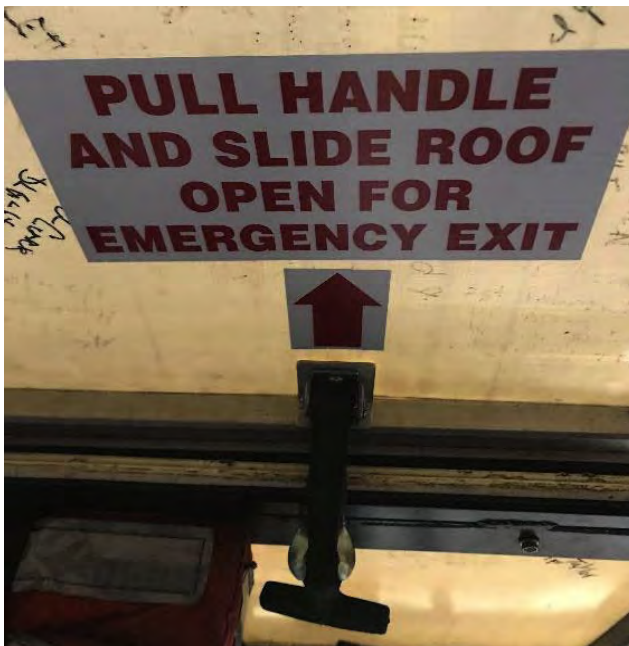
**FIGURE 5-8 Emergency handle with manual pull for sliding roof, Boston Duck Tours.**

The hatch is normally closed and has a handle with instructions to slide open in case of an emergency (see Figure 5-8).

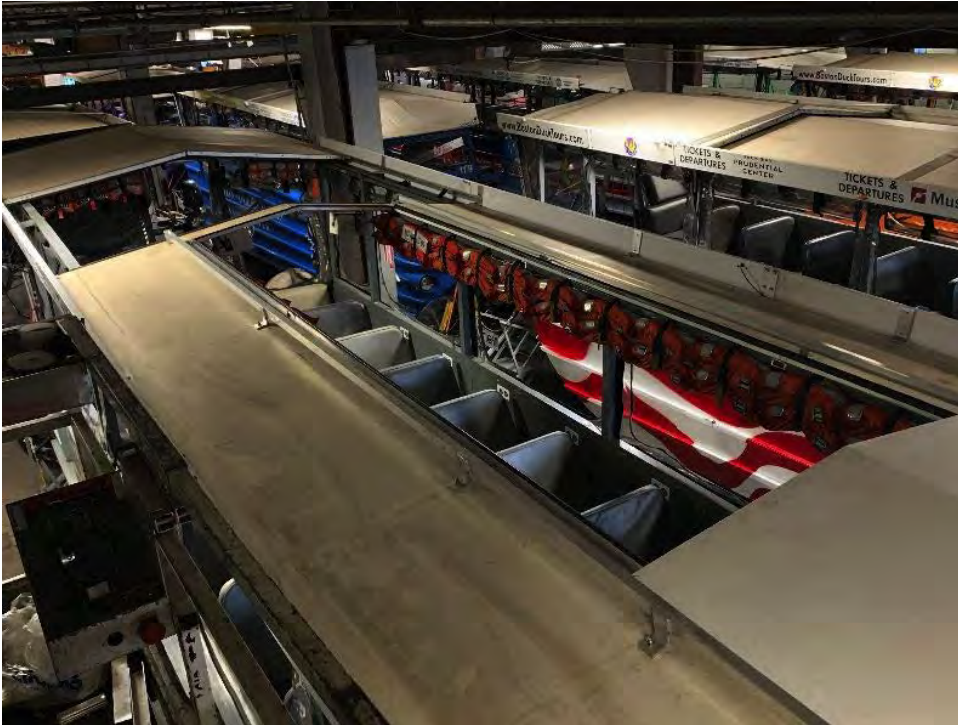
**FIGURE 5-9 Slide roof panels with centerline hatch, Boston Duck Tours.**  
SOURCE: T. Cerulle, Boston Duck Tours.

Boston Ducks has also developed another design, yet to be approved by USCG, that includes two hatches, the hatch in the stern area and a centerline hatch. The hatch at the stern slides aft. The centerline hatch is 11 feet by 4 feet and slides forward (see Figure 5-9).

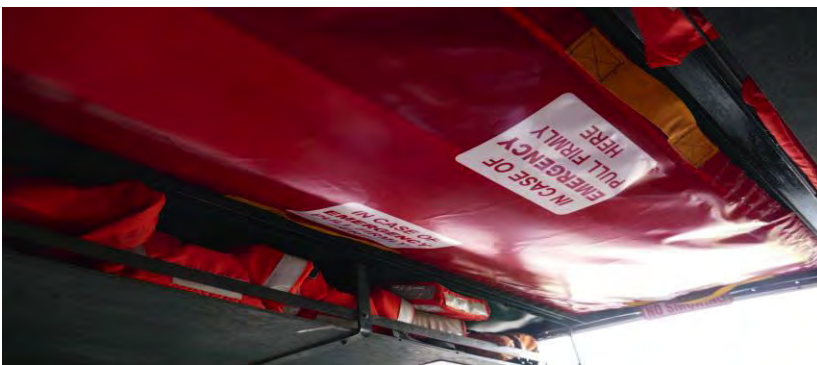
**FIGURE 5-10 Pull open canopy section, Original Wisconsin Dells.**  
SOURCE: T. Graul, committee member.

The Original Wisconsin Ducks has developed a removable center section that extends the full length of the canopy. It is opened in an emergency by pulling downward (see Figures 5-10 and 5-11).

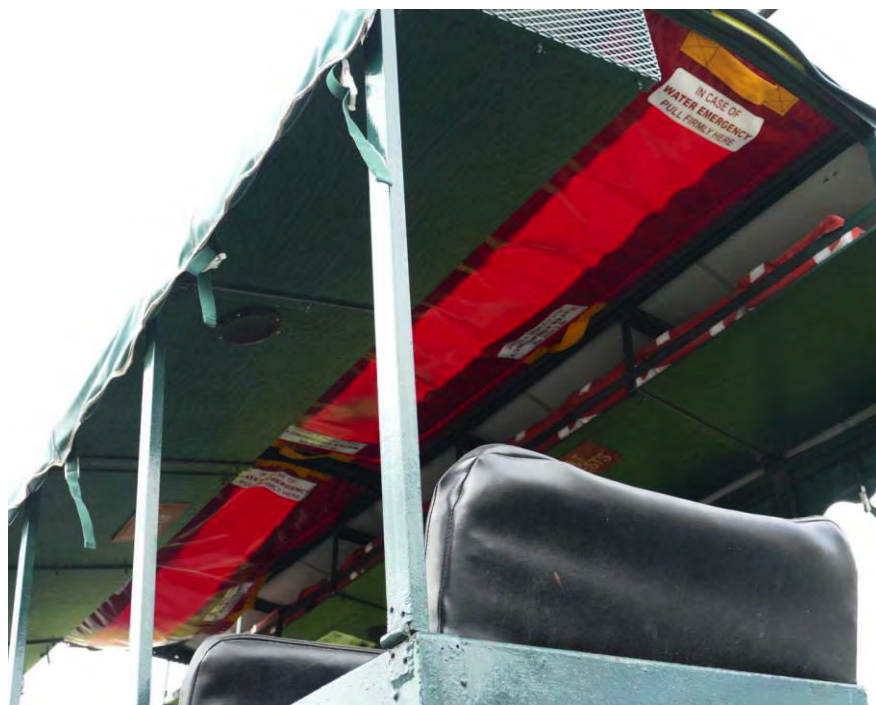
**FIGURE 5-11 Pull down canopy section on length of centerline, Original Wisconsin Dells.**  
SOURCE: T. Graul, committee member.

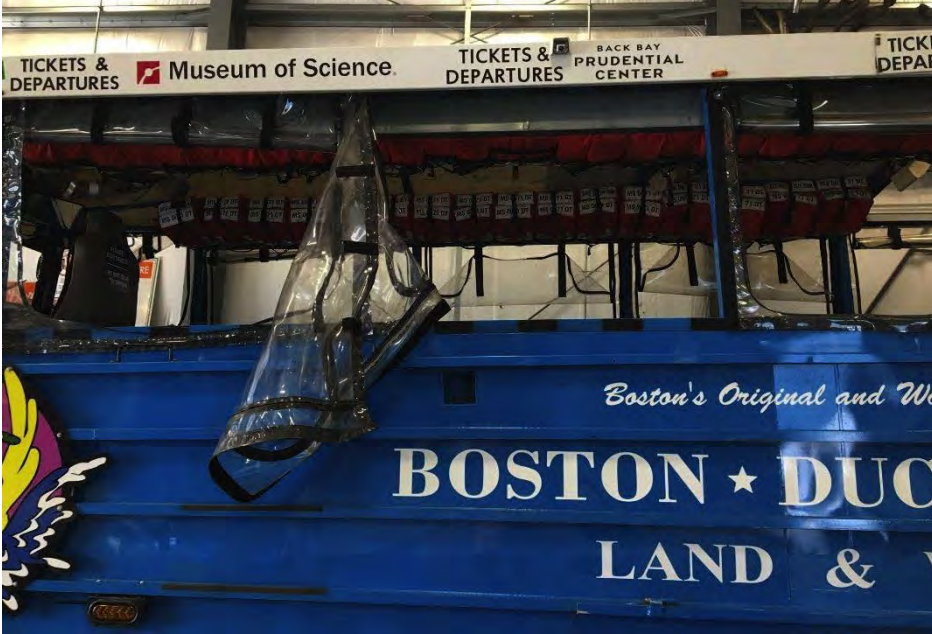
**FIGURE 5-12** Side curtains affixed with Velcro tabs, Boston Duck Tours.  
SOURCE: R. Cook, committee member.

All Boston Ducks are fitted with side curtains made of a piece of clear plastic for each window frame defined by the vertical supports. The canopy frame and supports are constructed of aluminum, and the supports provide an opening that is 4 feet 6 inches wide and 2 feet 10 inches high. The plastic windows are attached to the canopy frame using hook-and-loop (Velcro) fasteners and are easily removed or released for over-the-side egress. Figures 5-12 and 5-13 show a Boston Duck side curtain pushed open, like for an escape, and one stowed in rolled up position.

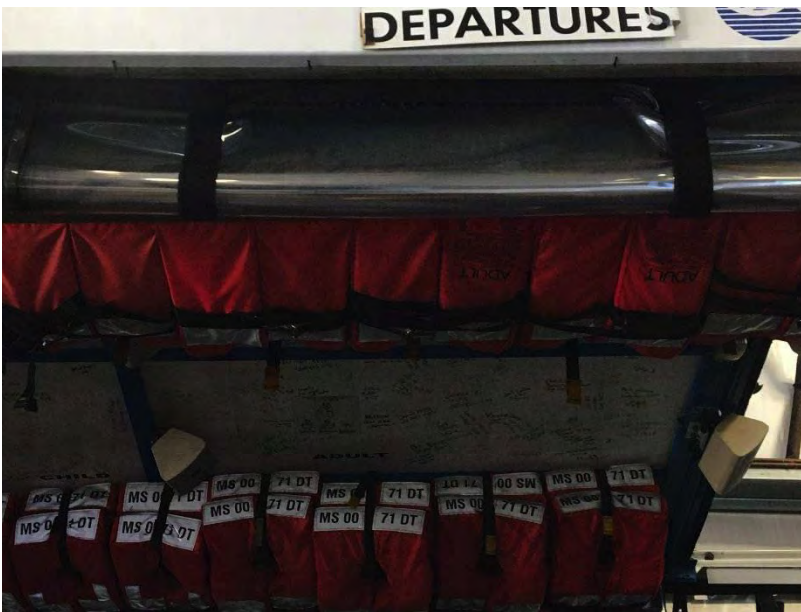
**FIGURE 5-13** Side curtain in rolled up position, Boston Duck Tours.  
SOURCE: R. Cook, committee member.

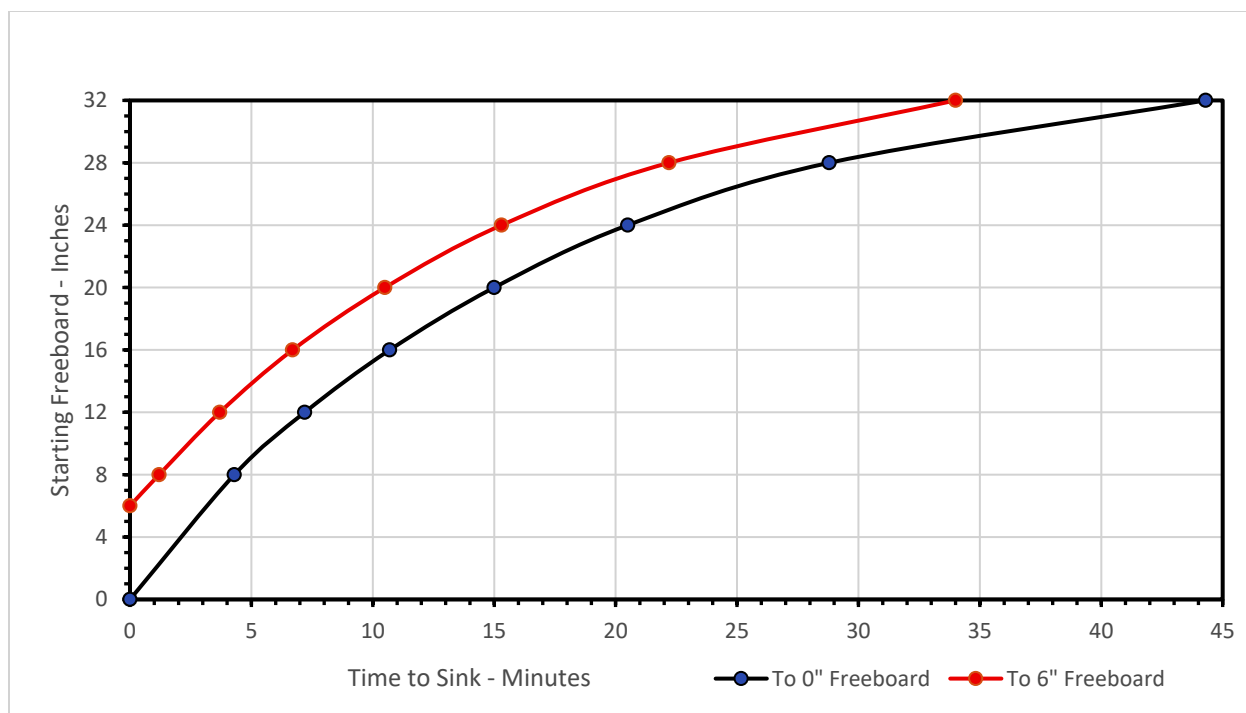
**FIGURE B-2 Results of DUKW boat time to sink analysis.**

Figure B-2 shows the results of the study. The black line labeled "To 0" Freeboard" is the theoretical maximum time for the DUKW to sink to the gunwale versus the starting freeboard.

The theoretical maximum time sink ranged from approximately 7 minutes at 12 inches starting freeboard, the low end of minimum permitted freeboards, to 30 to 35 minutes at the high end of the minimum permitted freeboards. At the mid range of permitted minimum freeboards, 20 to 24 inches, the calculated maximum time to sink was approximately 15 to 20 minutes.
